CROSS

Confidential Reporting on Structural Safety

NEWSLETTER No 25, JANUARY 2012

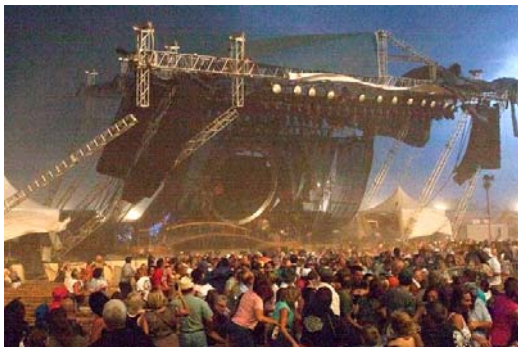
Collapse at Indiana State Fair August 2011
(Joey Foley/Getty Images)

- *Sugarland Concert Indiana August 2011 – main stage roof collapse with 6 fatalities and 44 injured*
- *Flaming Lips Concert Oklahoma August 2011 – large video screen collapse*

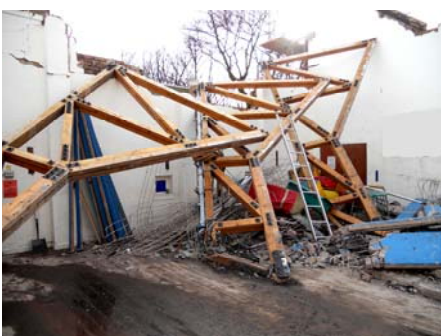
A gym/assembly hall roof to a school collapsed suddenly and without warning overnight when, fortunately the building was unoccupied. The building dates from the early 1960's and, in the view of the reporter, the collapse was due to a failure of the mid-span splice connections in the top and bottom chords of the bolted timber trusses which span the length of the hall (approximately 12m). The roof is flat over two thirds of its length but slopes upwards at 45 degrees at one end. A subsequent analysis of the trusses confirmed that the design complies with the Codes of Practice around at the time of construction, namely CP 112 (1952) and CP 3 (1952). However CP3 did not require the designer to consider the effects of snow drift loading. When snow drift loading is considered in the analysis, the mid-span splice connections to the top and bottom chord members are overstressed and this appears to be the reason for the failure. There was no snow on the roof at the time of the collapse. However during the previous winter the region where the building was located had experienced what is considered to be the heaviest and most prolonged period of snow fall for many decades. It is the reporter's opinion that this caused damage to the timber, causing it to split at the mid-span splice connections. High winds during the winter may have exacerbated the problem. There is significant damage to both top and bottom chord splice connections. The

School roof collapse

reporter believes that the bottom chord splice failed first. The damage to the top chord appears more dispersed and 'collateral' in nature. The reporter's concern is that any roofs of a similar period supported by bolted timber trusses and designed using the imposed load criteria of CP3 could be vulnerable if the shape of the roof is such that significant snow drift loading can occur.

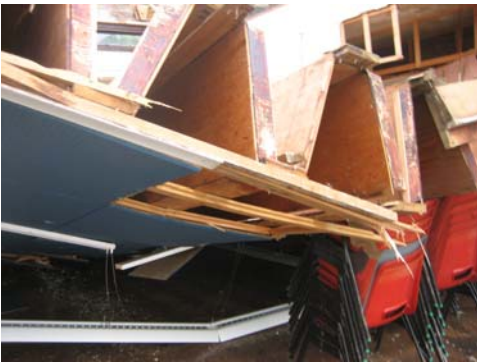
Collapse of Timber Roof

We were called, says a reporter, to investigate the collapse of a roof spanning 8m over a hall which was fortunately unoccupied and no one was hurt. The roof was constructed in 1959, and formed from a ply-web beam system, with hardboard ceiling and ply deck and asphalt covering. The asphalt had been felted, and then a further layer of insulation and felt applied. The roof had a parapet wall running around it, 100 to 150mm high, with internal rainwater outlets. There was evidence of ponding at one of the outlets and a lot of water was on the roof at the time of the collapse. Apart from creaking of the roof 15 minutes before the collapse, there was no warning. The roof was a proprietary system, which relied for support on end bearers glued and nailed to end stiffeners in the webs. The bearers sat on narrow ledges. This requires highly accurate construction of the supports; however, the failure mechanism in this case appears to be complete debonding of the end stiffeners and ply deck at one end, resulting in sudden shear failure. The end detail was a standard arrangement, as an alternative to sitting the beams directly on the supports. The system seems to have been used from 1953 or 1954 onwards and continued for at least 5 years (when the hall was built). The system is noted as a patented design in the 1976 version of the timber designers manual so may have been used for considerably longer. The system was used for walls, floors and roofs in a wide variety of buildings. The manufacturer however went out of business some years ago. Spans varied from 15ft to 42ft (4.57m to 12.80m). Decks at particular risk of this type of failure, believes the reporter, (until the end supports are verified) will include floor beams, decks with trimmed openings and roofs up to 9.1m span, (longer decks are less likely to have the end board detail but may still be subject to other types of failure, particularly in warm, humid environments). The only mechanical fastenings between the stiffeners and the web were small diameter nails, effectively panel pins, 3 or 4 each side, which he believes were only intended to provide gluing pressure for the joint. All such units with an end bearer detail should be regarded as dangerous and there may be hundreds in use. To identify these components a small hole and inspection with a boroscope would hopefully

This report raises a number of issues: water ponding as a result of blocked outlets which cannot be seen from ground level, deterioration of timber (and glued components) arising from wetting conditions through water ingress, and possibly details associated with the bearing such as the bearing length. At the time of construction such plywood box beams were either structurally glued or structurally nailed. If structurally glued then tacking nails were used to hold the assembly together while the glue cured. After curing the nails were redundant and not considered in the design. In structurally nailed assemblies there was a designed dense nailing pattern along flanges and down stiffeners and 11 gauge galvanised nails were commonly used. The glues that were typically used are water resistant if applied correctly and plywood web beams were good structural elements provided that manufacture and construction practice was controlled. It may be that the design and construction were satisfactory but that a lack of maintenance allowed rainwater ingress to occur. This could have affected the timber at the glueline, or the failure may have been related to support conditions, or it could have been a combination of the two. Whatever the cause this is a potentially serious issue and possibly there ought to be a requirement in building management to periodically check long span roofs. As suggested by the reporter the use of a boroscope could be helpful when assessing conditions at bearings. In the section on robustness in Approved Document A there is a clear indication of higher risk when the consequences of failure are multiple injuries. In this case, and that of report 242 (above in Newsletter No 25) there were long span roofs over school halls where the risk of injury could be very high. There have been previous examples of roof failures in schools which prompted large scale investigations. In 1973 at Camden School the beams made from concrete containing high alumina collapsed and many similar structures were checked and some strengthened: see [Question on high alumina cement](#). In 1976 the timber roof over the gymnasium at Rock Ferry School collapsed again resulting in widespread checks of such structures. For example see [The Structural Engineer volume 78, Issue 1, A Century of Innovation: Structural Engineering 1900 - 2000](#).

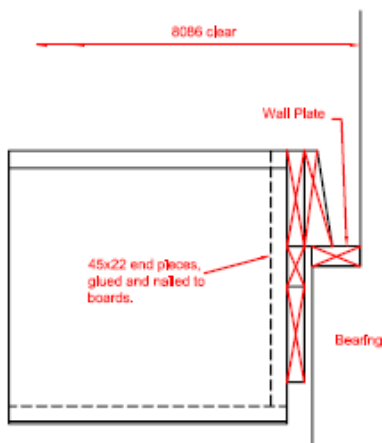
Side View at Bearing

be enough as the members are quite distinctive, with their inclined webs, but these of course may be hidden by ceilings. Figures show the aftermath of the collapse, an exploded view of the form of construction, and a side view drawing of the bearing.
