Confidential Reporting on Structural Safety

NEWSLETTER No 36, OCTOBER 2014

399 TOWER CRANE – FAILURE OF A LOAD BEARING PART

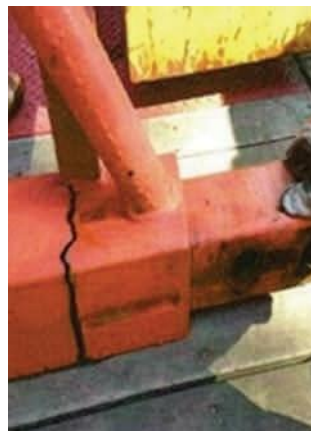
A tower crane suffered a failure of one of its four main legs approximately 12m below the slew ring. The fault was discovered, says the reporter, as a result of the tower crane operator noting some unusual banging and vibrations from what he believed to be the slewing ring. The crane was immediately taken out of service and an inspection carried out. This revealed that there was no fault with the slew ring but identified a failure in the leg. The crane was dismantled, the part replaced, and a new Certificate of Thorough Examination was issued by an independent company. At the time of reporting it was not known what caused the failure and a full investigation is underway. This incident has been reported to the HSE as a dangerous occurrence and the contractor issued an instruction to all sites to immediately carry out appropriate inspections of such cranes in consultation with the tower crane provider/operating company. In an update the reporter has pointed out the recommendations from

Crane in position

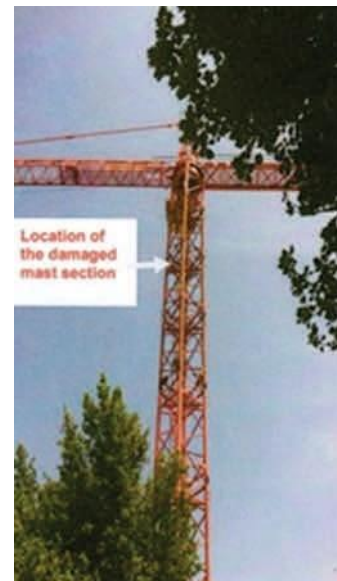
Fractured section

The investigation is not yet complete but an obvious candidate for a failure of this kind is fatigue cracking. There are two phases of fatigue damage: crack initiation and crack propagation. Both phases are linked to repeated application of stress. Fatigue cracking is a potential mode of failure on any moving structure but its initiation and rate of propagation are rather uncertain. Hence a fundamental plank of safety is the ability to inspect with the objective of detecting a crack before it progresses far enough to be dangerous. This is a really good example of a near miss from which we can all learn. Any piece of steelwork which is subjected to repeated and/or cyclic loading should be inspected for fatigue loading. The incident supports the need and obligation for regular inspections but also to consider whether the usage of a crane in some circumstances might warrant more frequent inspection? For example, lighter loads but very frequent and repetitive use (creating reversals of stress) may be more harmful than occasional heavy loads. The recommendations in [CPA TIN042](#) are to be welcomed. There are other structures which are composed of a kit of parts each of which may have had a different history of use; for example temporary stages or even scaffolding. The history/residual fatigue life of the individual components will probably not be known. Is there a need for more rigorous systems for detecting fatigue in construction equipment components? It is taken very seriously in the aircraft industry.

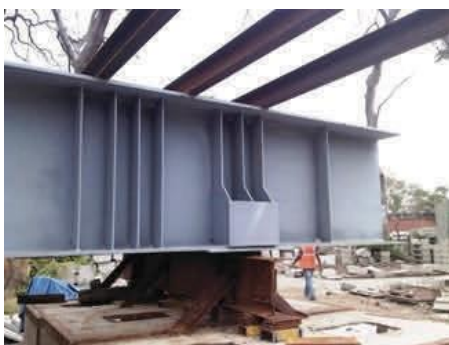
A composite steel girder was designed to support the platform for a Metro Rail station and it was decided to do a working load test on it at the fabrication yard before erection. Unfortunately the load test setup failed due to over-estimation of the capacity of the ISMB (Indian standard steel beam) provided for supporting the girder.

- 1) A detailed 3D analysis simulated the design bearing load over the ISMB-300 member and it was found that the stresses in the member were more than 3 times greater than yield strength.
- 2) The design size of the Elastomeric bearing pad was greater than the flange width of the ISMB300 so the bearing area was insufficient.
- 3) The main cause of the failure of the load test was the lack of proper stiffening plates.

Test load setup

Assuming that it was an overestimation of the strength of the supporting member then the lesson is that test rigs should be designed to the same level of detail as the piece being tested. SWL need to be defined for the test rig, as often the tested piece may be significantly stronger/stiffer than expected and loading to deflection/failure criteria of the test piece can fail the rig. As is so often the case attention to detailing is required. All elements on the load path need to be looked at - there is always a weakest point.

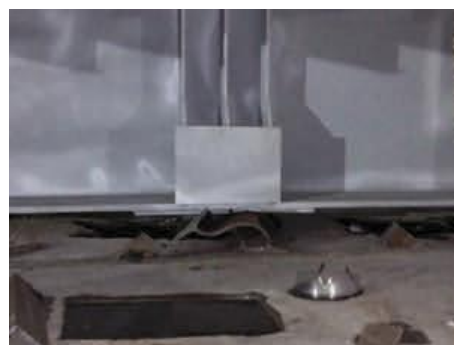
Remains of the supporting beam
